The Glass Plate Negative Project at the Heritage Conservation Centre

Tay Jam Meng

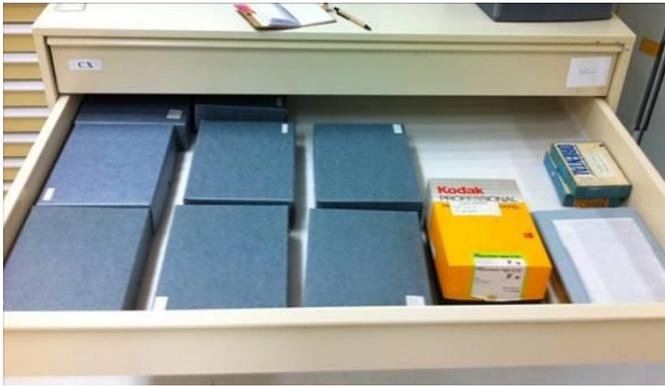
This project began with a preliminary survey carried out in 2011 by the HCC Paper Section. From the survey, it was found out that the plates were not housed in proper conditions. Most of the early housing methods and materials were in need of improvement (figs. 3, 4) as they had resulted in damage to the plates. In addition, this collection had never been surveyed or treated by trained photograph conservators. This project presented a good opportunity for HCC to examine and preserve this historical collection, while building a more in-depth understanding of it. Following the preliminary survey, a detailed, randomized survey was carried for the first 100 plates, which eventually lead to the conceptualization and implementation of this project.

Fig. 3. Glass plate negatives were stored inside the document drawers at HCC archival storage.

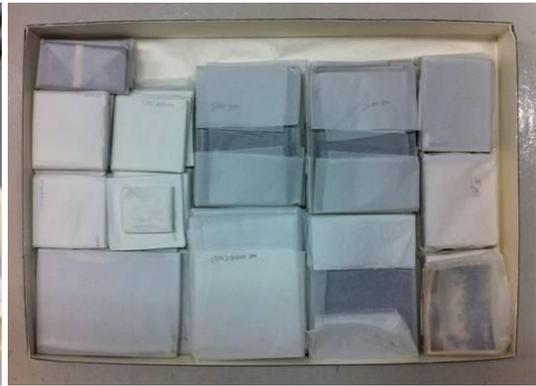
Fig. 4. Assorted plate formats were stacked inside each box.

During the survey, it was observed that all the different-sized plate formats were stacked horizontally on top of each other. This storage method was inappropriate as it placed significant pressure to the plates, particularly those at the bottom of the stacks, and also compromised safe handling. In order to improve this storage system, the conservation team decided to adopt a vertical storage system, helping to achieve the project objectives of easy object retrieval while promoting safe handling of the collection.

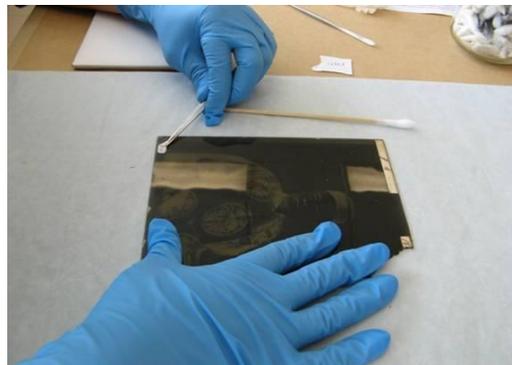
Fig. 10. Pressure sensitive labels were removed during the treatment process.

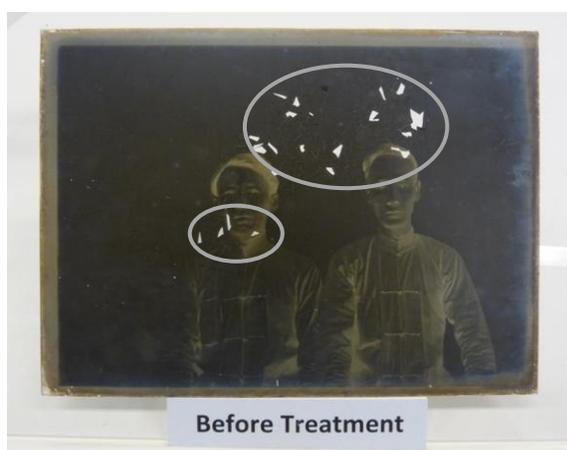
The condition of Cat. 3 plates was varied. Most suffered from one or more of the following: severe accretions on the emulsion side, paper accretions/residue overall, dried mould stains, plate breakage, and emulsion lifting or flaking as seen in figures 12 and 13. In order to address these issues, treatment of the emulsion surface was required. Extra care was taken as the emulsion can be very sensitive to moisture, especially if the emulsion had degraded. They were surface cleaned with a soft bristled squirrel hair brush, minimizing the risk of scratching. Pressure sensitive labels adhered to the emulsion sides were removed mechanically. Depending on the amount of tape residue, a swab lightly dampened in a water/ethanol (90:10) solution was used to gently remove the label. This was only done when the emulsion layer had no damage or presented no risk of flaking.

Fig.12. Emulsion flaking and loss on a wet collodion plate. Courtesy of the National Heritage Board, Singapore.

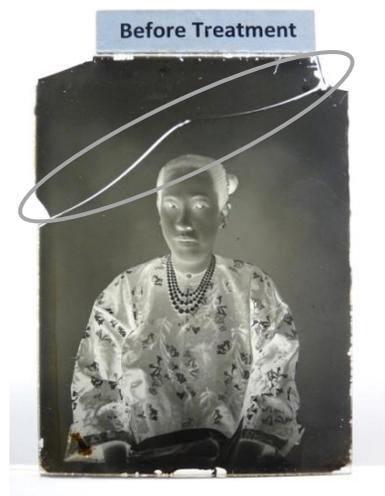
Fig.13. Broken glass plate negative. Courtesy of the National Heritage Board, Singapore.

For the treatment of the broken glass plate negatives, the team adopted the repair method developed by Katherine Whitman (Whitman and Wiegandt 2007). The broken shards of glass are aligned and adhered vertically with the aid of *lightline* as recommended. A slight modification was made to Whitman's method by using button-size magnets on opposite sides of the plates to hold them together during alignment and adhesion, instead of wax, which was recommended. The decision to use magnets was taken as most of plates that are broken are not severely shattered. This method was first encountered and experimented with during an internship the author undertook at the Canadian Conservation Institute (CCI) in 2010 (fig. 14). Silicon release Mylar is placed between the

magnets and the plate to prevent the magnets from adhering to the plate if excess repair adhesive is present. After the treatment, the plates are placed in sink mats in order to minimize direct handling, potentially dislodging the shards.
