# ASSESSMENT ON THE RATE OF EFFECTIVENESS OF POLLUTANTS SCAVENGERS ON HYDROGEN SULPHIDE

By Lee Swee Mun  
Senior Objects Conservator  
Heritage Conservation Centre

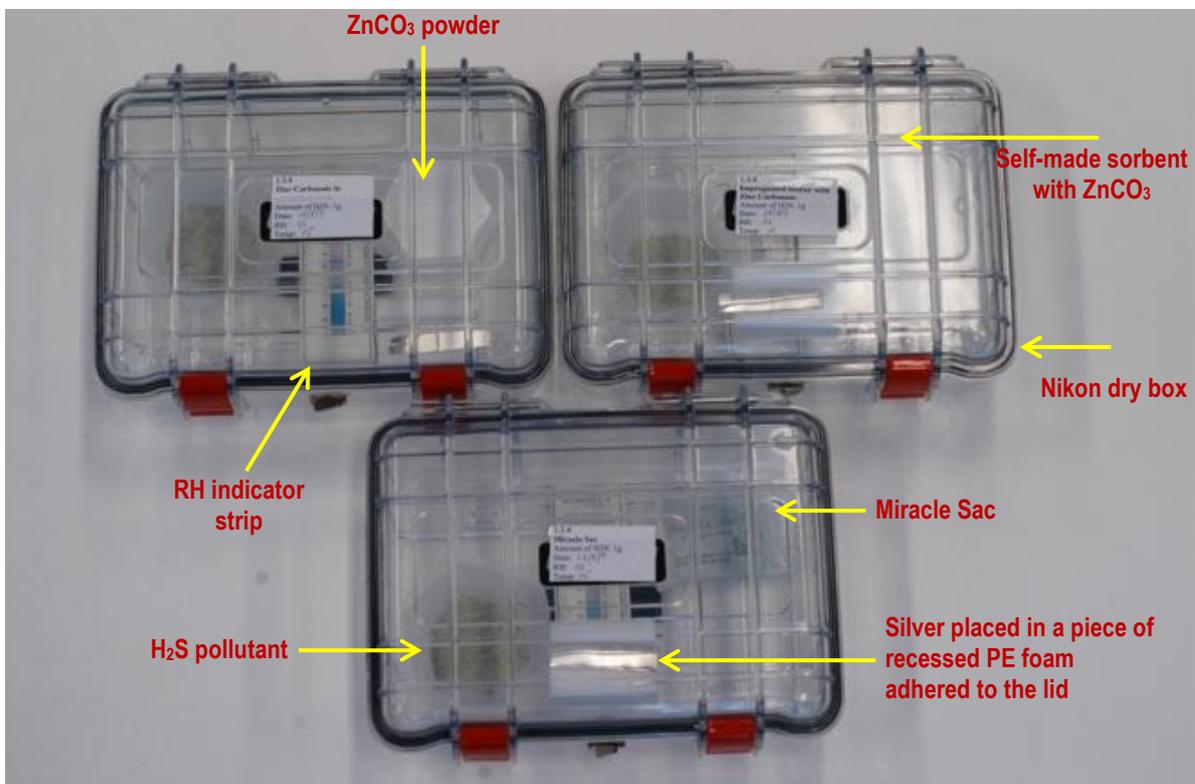
Figure 1: Setups for 55-65% RH museum environment (1.3.4)

Each environment consisted of a control and 3 types of scavengers making a total of 4 setups. Each setup included a humidity strip; a strip of sterling silver (5 X 1 cm) that was barrier coated with Agateen lacquer on half a side to protect the surface from tarnishing while the other side exposed to  $H_2S$ ;  $H_2S$  in powder form as pollutant; fresh silica gel beads were incorporated to simulate a less than 55% RH micro-environment; and a  $H_2S$  scavenger (Figures 1 and 2). The 3 scavengers were Miracle Sac™, self-made zinc carbonate solution applied on acid-free blotter as described in Appendix A, and plain zinc carbonate ( $ZnCO_3$ ) powder. A relatively air-tight box (Nikon camera dry box) was used to construct a micro-environment across the 16 setups in order to achieve consistent and repeatable outcome. The full details of the setup were described in Table 2.1.

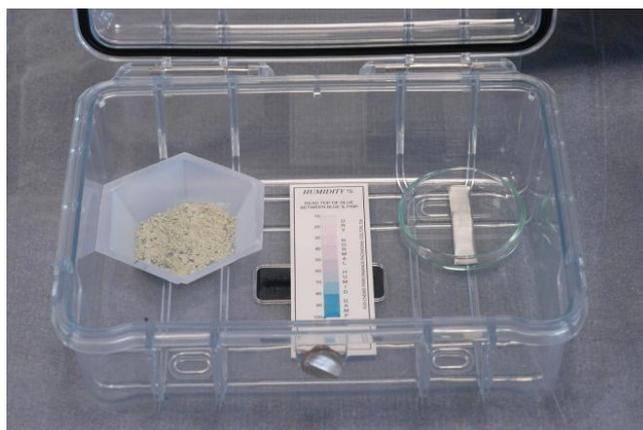
Figure 2: Setup for Controls 1.4.2, 1.4.3 & 1.5

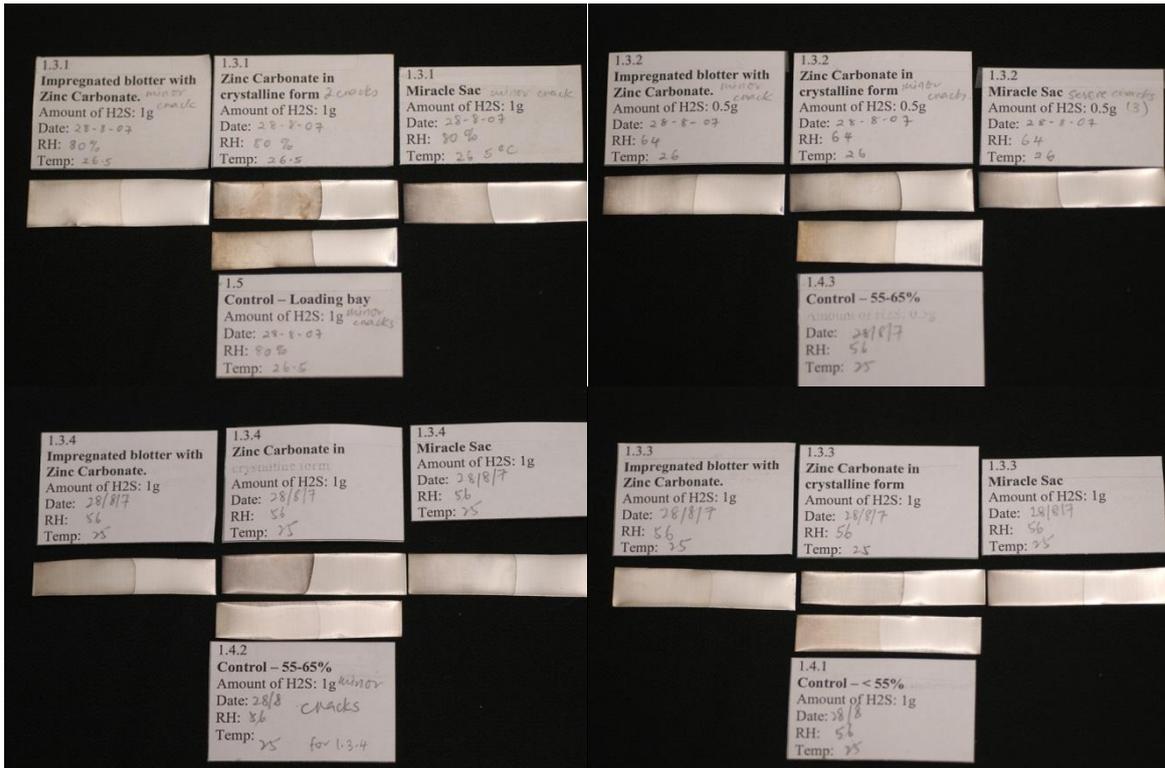
Figures 3 – 6: Visual assessment and comparison between silver coupons. From top left clockwise: open and uncontrolled environment (Loading Bay 1.3.1); enclosed and uncontrolled environment (Conservation Workroom 1.3.2); low RH environment (Objects Lab 1.3.3); and 55-65%RH environment (objects Lab 1.3.4)

The tarnish on the silver coupons was compared across those in the same environment and against the control. The results were tabulated (Table 3.1) and coupons used in the same environment were photographed (Figures 3 – 6) together for ease of comparison.

All the silver coupons were visually assessed with the loupe under daylight. It was obvious that the silver coupons in an open and uncontrolled environment tarnished the most, while in the low RH environment tarnished the least. The silver coupons in the 55-65%RH environment comparatively acquired more tarnish than the low RH environment and better than the coupons in the enclosed uncontrolled environment. The black dots of corrosion took place almost immediately on the silver coupons when the experiment started. This was likely caused by air movement and deposition of H<sub>2</sub>S powder onto the silver surface while the boxes were being handled. No further black dots of corrosion occurred subsequently. A few black dots also occurred on the area of the silver coupons coated with Agateen. This implied that the coating was slightly uneven and therefore unable to fully protect the silver. However, the coated surfaces remained shiny and no dulling. It appeared quite frequently that the edges of the silver coupons were

preferentially tarnished and darker. This was due to the surface structure of silver. Some coupons also had darker surface located at the short side of the uncoated silver because the coupon did not completely rest within the recessed PE foam but partially jutted out allowing it for more direct exposure to H<sub>2</sub>S.

It was observed that self-made sorbent with zinc carbonate performed the best in the uncontrolled environments. It was marginally better than Miracle Sac™ for the uncontrolled enclosed environment (1.3.2). It clearly appeared to be more effective in the uncontrolled open environment (1.3.1), which could be due to the moisture absorbing quality of the acid-free blotter with larger surface adsorption area, therefore slowing the rate of tarnishing. It was also observed that the ZnCO<sub>3</sub> on the acid-free blotter for 1.3.1 appeared cemented and much less flaky than the ones for 1.3.2, 1.3.3, and 1.3.4. On the other hand, Miracle Sac™ performed slightly better than self-made sorbent with zinc carbonate both in the low RH environment and 55-65%RH environment. The silver coupons with plain ZnCO<sub>3</sub> powder as scavenger appeared most tarnished compared with Miracle Sac™ and self-made sorbent with zinc carbonate.

Last but not least, coating silver with Agateen has evidently shown that it was effective in protecting silver from tarnishing whether in controlled or uncontrolled environment, as the coated side of the silver coupons did not tarnish at all, except a few black spots of corrosion caused by the deposition of H<sub>2</sub>S particles onto the surface.

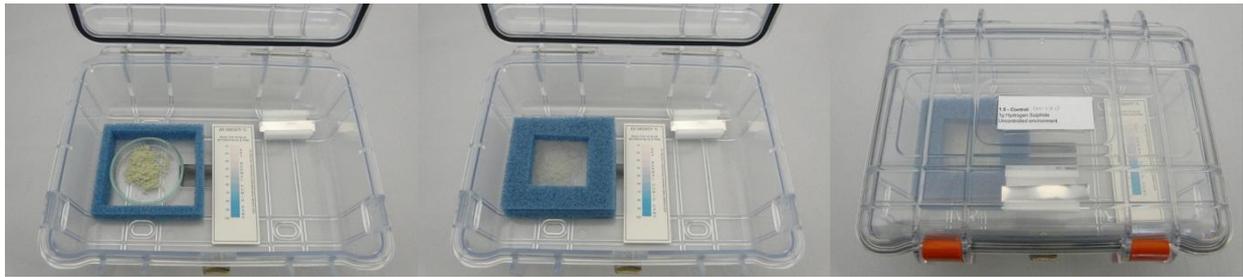
Figures 7 – 9: Layout of control setup. H<sub>2</sub>S powder is covered over with a piece of fine woven nylon gauze. Silver coupon is placed in a piece of recessed PE foam adhered to the lid on the inside of the dry box

In the second experiment, some changes were made to the setup. The H<sub>2</sub>S used in the control setups was covered over with a piece of fine woven nylon gauze (Figures 7 – 9) in order to reduce movement of the powder through handling. For the other setups, scavengers were placed directly on top of the H<sub>2</sub>S pollutant to improve filtration (Figures 10 – 14). The silver coupon continued to be elevated in the dry box. It was placed in a piece of recessed PE foam and the foam was in turn adhered to the lid on the inside of the dry box. Another change made to the experiment was the change of monitoring location for enclosed and uncontrolled environment (1.3.2). In the first experiment, the space next to the window in Conservation Workroom was chosen. In the second experiment, the office space was selected as it better represented an enclosed air-conditioned yet non-RH controlled space without direct exposure to sunlight. The temperature had an indicative range of 22.5-25°C and RH 50-64%.

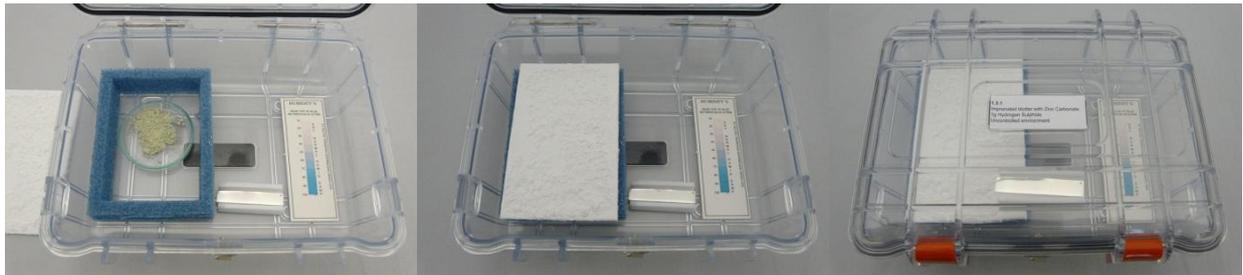
Figures 10 - 12: Layout of self-made H<sub>2</sub>S sorbent with zinc carbonate. The scavenger is placed directly on top of the pollutant H<sub>2</sub>S

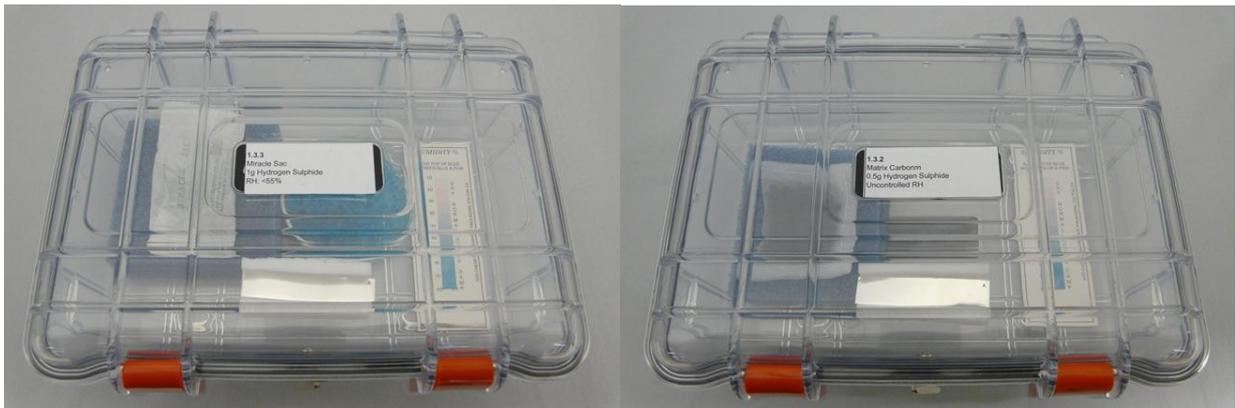
Figures 13 – 14: Layouts of Miracle Sac™ and MatrixCarbon™

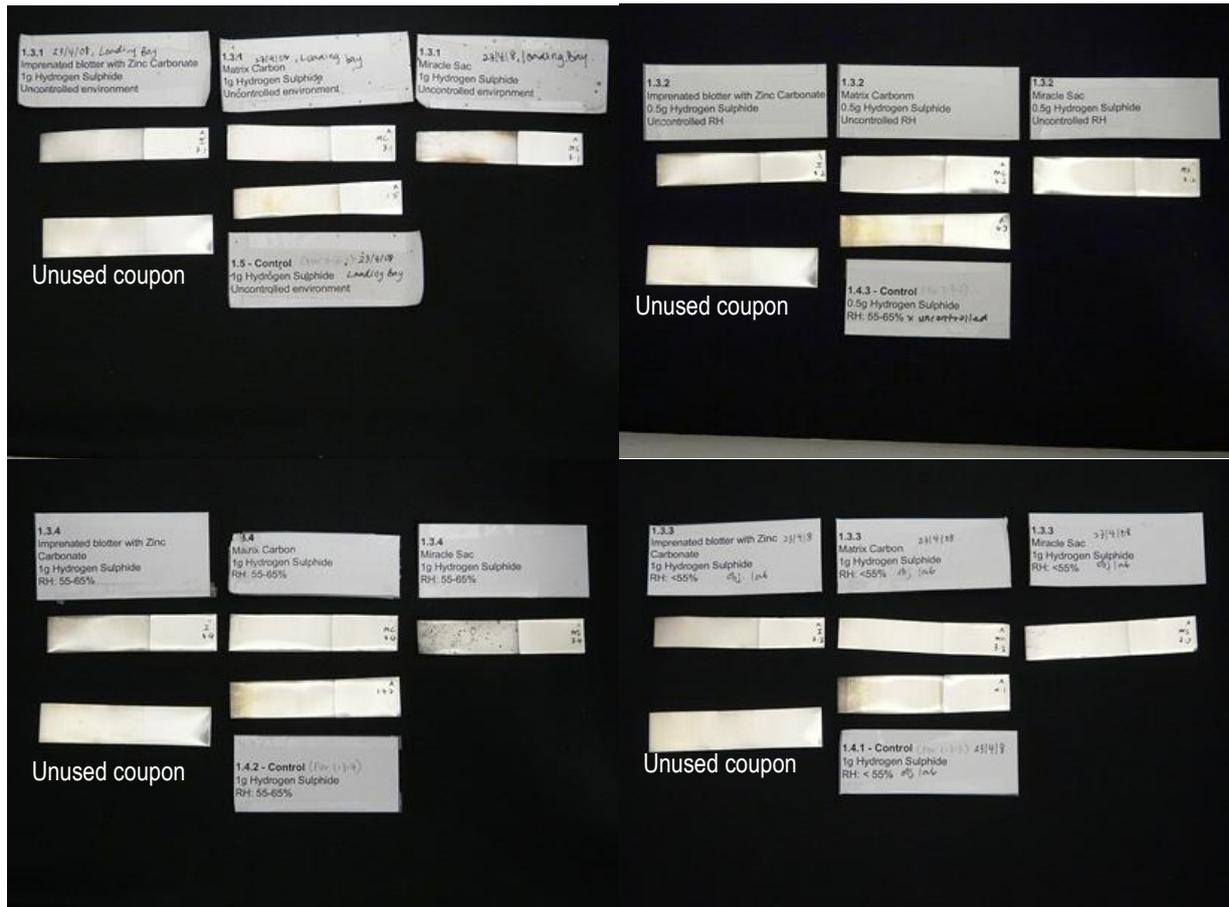
Figures 15 – 18: Visual assessment and comparison between silver coupons. From top left clockwise: open and uncontrolled environment (Loading Bay 1.3.1); enclosed and uncontrolled environment (Objects Office 1.3.2); low RH environment (Objects Lab 1.3.3); and 55-65%RH environment (objects Lab 1.3.4)

The tarnish on the silver coupons was compared across those in the same environment against its control. The results were tabulated (Table 5.1) and photographed (Figures 15 – 18) together for ease of comparison. The method of assessment was the same as the first experiment. In addition, a clean and unused silver coupon that was barrier coated with Agateen on half a side was used as a visual reference to gauge the level of tarnish on all the 16 coupons including the controls.

All the silver coupons were visually assessed with the loupe under daylight. With the scavenger now placed directly above the pollutant, the level of tarnish was less on the coupons when compared in adjacent with those in the same environment from the previous experiment except Low RH environment (1.3.3). The number of black dots of corrosion was also substantially reduced after a change in the layout. Unfortunately, the coupons monitoring Miracle Sac for 1.3.1 and 1.3.4 could not provide good indication on its performance. High RH of the uncontrolled open environment did not seem to impact significantly on level of tarnish generally. The level of tarnish under the low RH environment was moderately less than those in the other 3 environments. The edges of the silver coupons have preferentially tarnished and darker and this was due to the surface structure of silver. Some coupons also have darker surface located at the short side of the uncoated silver because the coupon jugged out from the recessed PE foam leading to more direct exposure to H<sub>2</sub>S.

MatrixCarbon™ clearly performed the best in all the environments compared with the other 2 scavengers and also less tarnished than the respective control coupons. Self-made H<sub>2</sub>S sorbent with zinc carbonate appeared more effective than Miracle Sac™ under uncontrolled and open environment (1.3.1) which could be due to the moisture absorbing quality of the acid-free blotter and larger surface adsorption area for H<sub>2</sub>S, therefore slowing the rate of tarnishing. On the other hand, Miracle Sac™ seemed more

Control coupons were expected to be most tarnished in the absence of scavengers for all environments, but not for 1.3.1 and 1.3.4. The most possible explanation could be that the fine woven nylon gauze had effectively acted as a barrier in preventing the H<sub>2</sub>S powder from dispersing via air movement resulted from air exchange between inside and outside of the dry box.
