The Glass Plate Negative Project at the Heritage Conservation Centre

Tay Jam Meng

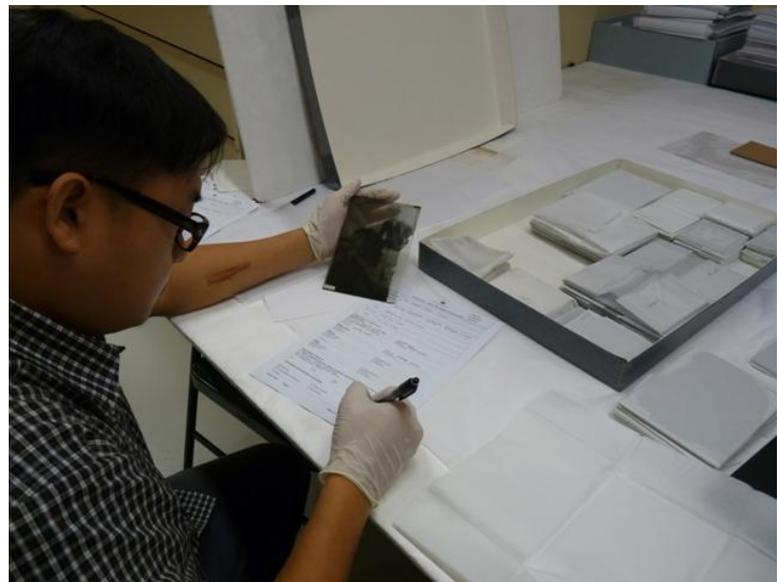
The collection was assessed according to its condition and further categorized according to treatment needs. Three categories were assigned: Category 1 (Cat. 1) - no treatment, Category 2 (Cat. 2) - minor treatment, and Category 3 (Cat. 3) - moderate to major treatment (see table 1). This categorization process was important as it helped to estimate the amount of time and funds required for the entire project. From the 2011 survey, approximately 90% of the plates were identified as requiring some form of conservation treatment,

Fig. 5. A randomized survey was carried out in early 2012.

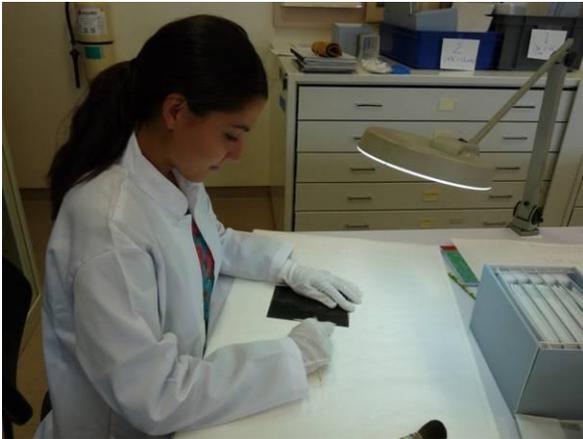
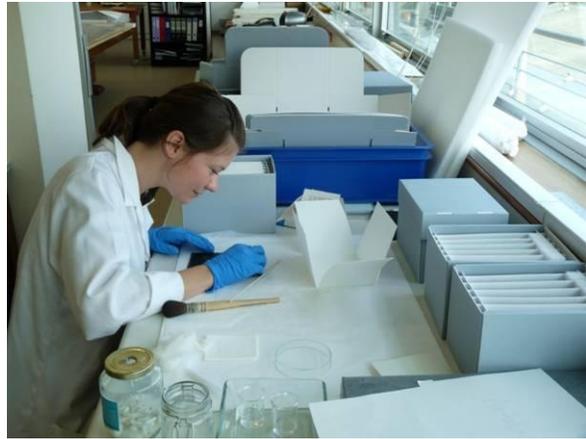
Most of the glass plates were categorised as Cat. 2, and the treatments carried out for this categorization involved mainly the glass sides of the negatives. These Cat. 2 materials were considered structurally stable; however, they exhibited dirt, accretions, and finger marks which necessitated surface cleaning. Pressure sensitive tape labels having no historic value were removed mechanically (fig. 10). Swabs dampened with water/ethanol solutions (50:50 or 70:30, depending on the requirements of each object) were used for reducing stains or tape residues.

Figs. 8, 9. HCC interns, Ms Alison Bryan and Ms Emily Hick carrying out glass plate negative Category 2 treatments.

Whatman lens tissue, which has a smooth surface and does not leave fibres behind, was used to gently wipe off any residual marks. HCC conservators were assisted with these Cat. 2 treatments by two interns, Ms Alison Bryan and Ms Emily Hick, during their internship programs with the HCC (figs. 8, 9), during which Ms Bryan and Ms Hick worked under the supervision of the HCC paper conservators.

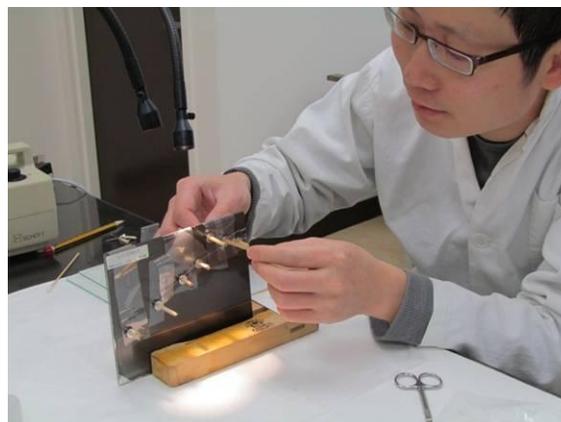
Fig. 14. The author repairs a glass plate negative during an internship program at the Canadian Conservation Institute.

For the treatment of the broken glass plate negatives, the team adopted the repair method developed by Katherine Whitman (Whitman and Wiegandt 2007). The broken shards of glass are aligned and adhered vertically with the aid of *lightline* as recommended. A slight modification was made to Whitman's method by using button-size magnets on opposite sides of the plates to hold them together during alignment and adhesion, instead of wax, which was recommended. The decision to use magnets was taken as most of plates that are broken are not severely shattered. This method was first encountered and experimented with during an internship the author undertook at the Canadian Conservation Institute (CCI) in 2010 (fig. 14). Silicon release Mylar is placed between the

magnets and the plate to prevent the magnets from adhering to the plate if excess repair adhesive is present. After the treatment, the plates are placed in sink mats in order to minimize direct handling, potentially dislodging the shards.

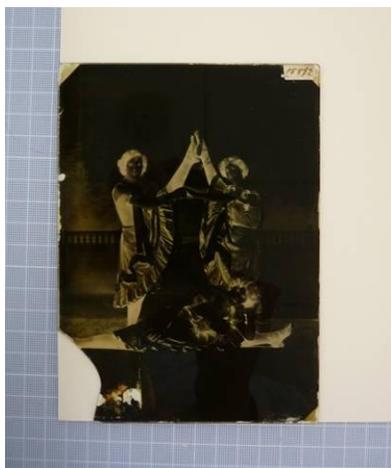
Fig. 15. The plate was placed over the board and was aligned on left and right sides.

Plates that were found to have moderate cracks or edge losses required immediate attention in order to reduce the chances of further damage occurring. Museum quality mat board was used as rigid secondary supports beneath the plates in the four-flap folders. For plates with larger losses, which could be further damaged, another piece of mat board was cut and added as an 'in-fill,' providing additional support during storage. By tracing the shape of the losses with a fine tip pen and Mylar sheet overlay, an appropriately-sized 'in-fill' was cut (figs.15, 16). The 'in-fill' was then adhered to the secondary support mat board with 3M #415 double sided tape. It was found that 4-ply mat board was matched the thickness of most of the glass plates. The negatives were then placed together with the secondary support board and 'in-fill' (figs. 17, 18) in a 4 flap folder in order to minimize further damages when handled.

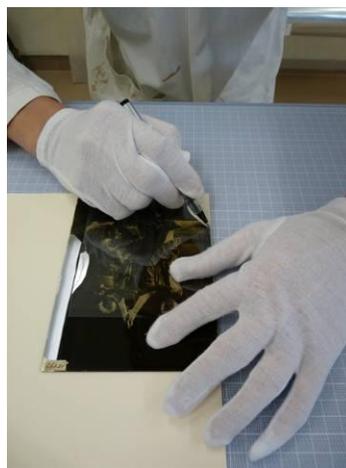
Fig. 16. Fine tip pen and Mylar sheet was used to trace the loss area.

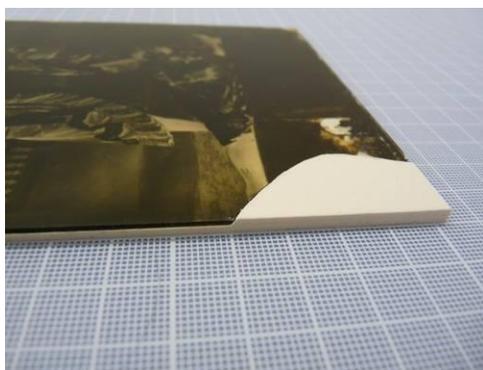
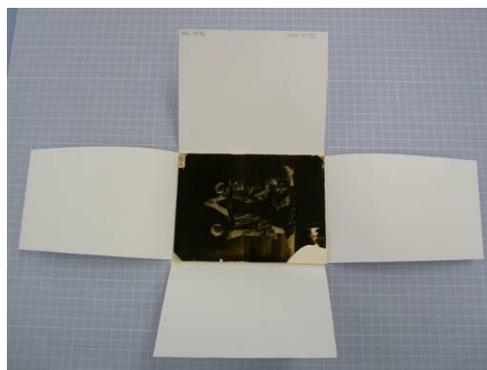
Figs. 17, 18. The plate was placed on the backing board and fitted into the 'in-fill' board (*left*) before storing into the four flap folder (*right*).
